P C Home Inspection

Property Inspection Report

185 Fairgreen, Fullerton, CA 92833

Date of Inspection: 12/18/2025

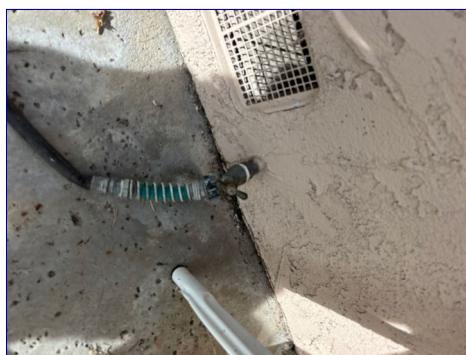
10. Hose Bibs

- Recommend anti-siphon valve

- At least one hose bib is not equipped with an anti-siphon device. A possible cross-contamination can occur, which is a potential safety concern. A licensed plumber should install an anti-siphon/vacuum breaker.

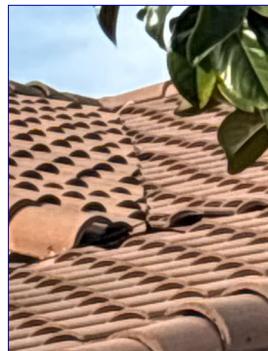
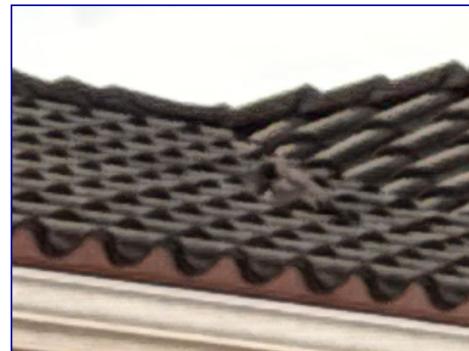
6. Valleys

- The roof **valleys** inspection is limited to the visual portion of the valleys. There is always the potential for hidden damage in non visible areas. Recommend monitoring and consulting a licensed roofer as needed.
- The roof **valleys** inspection is limited to the visual portion of the valleys. There is always the potential for hidden damage in non visible areas. Recommend monitoring and consulting a licensed roofer as needed.

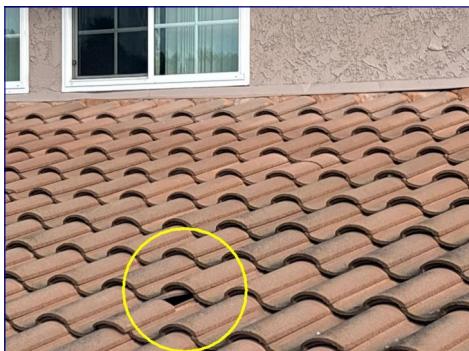
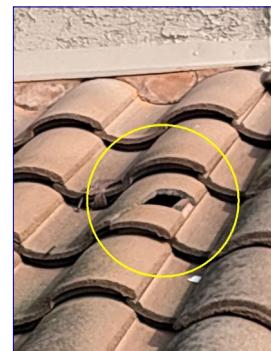
7. Condition of Roof Covering

Page 9 Item: 7	Condition of Roof Covering	• One or more broken/loose tiles exist on the roof. Recommend a licensed roofer to replace the damaged tiles.

- Broken/Loose tiles/Shingles
- Recommend roofer evaluate

- One or more broken/loose tiles exist on the roof. Recommend a licensed roofer to replace the damaged tiles.
