P C Home Inspection

Property Inspection Report

185 Fairgreen, Fullerton, CA 92833

Date of Inspection: 12/18/2025

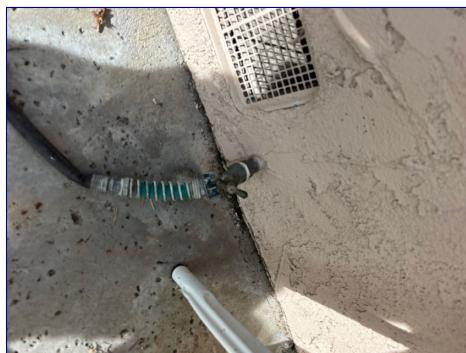
10. Hose Bibs

- Recommend anti-siphon valve

- At least one hose bib is not equipped with an anti-siphon device. A possible cross-contamination can occur, which is a potential safety concern. A licensed plumber should install an anti-siphon/vacuum breaker.

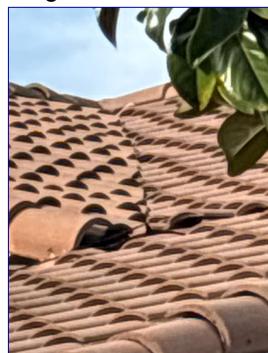
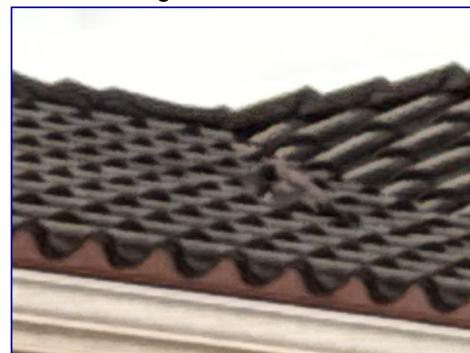
6. Valleys

- The roof **valleys** inspection is limited to the visual portion of the valleys. There is always the potential for hidden damage in non visible areas. Recommend monitoring and consulting a licensed roofer as needed.
- The roof **valleys** inspection is limited to the visual portion of the valleys. There is always the potential for hidden damage in non visible areas. Recommend monitoring and consulting a licensed roofer as needed.

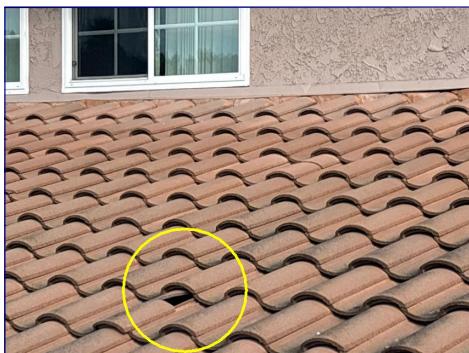
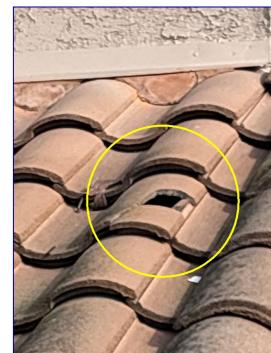
7. Condition of Roof Covering

- Broken/Loose tiles/Shingles
- Recommend roofer evaluate

- One or more broken/loose tiles exist on the roof. Recommend a licensed roofer to replace the damaged tiles.
