# PROPERTY INSPECTION REPORT

**Peter Chung  
P C Home Inspection**

**1065 Lomita Blvd SPC 201  
Inspection Prepared For: Mi Chung  
Agent:**

**Date of Inspection: 12/4/2025  
Year Built: 38 Size: 1500  
Weather: Sunny**

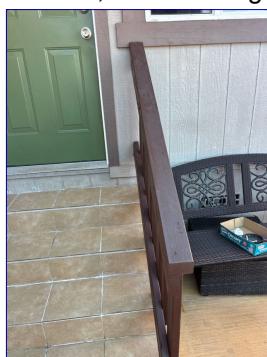
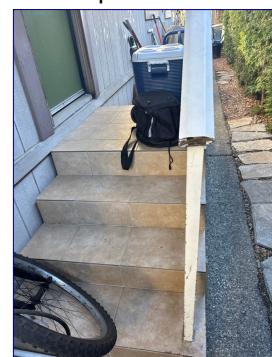
Materials:  
• Wood  
Condition:  
• Safety hazard  
Observations:  
• There are horizontal railings on the exterior steps. Horizontal railings present a climbing and falling hazard. Wooden hand rail, too wide to grasp. Recommend a professional contractor repair.

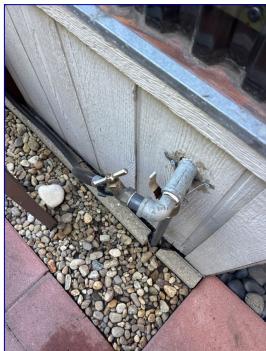
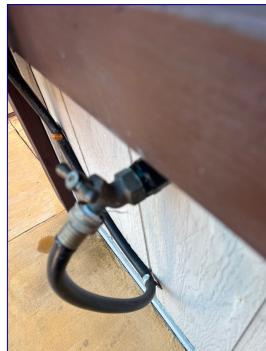
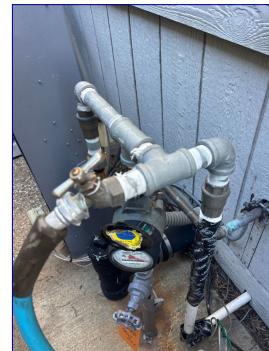
- Recommend anti-siphon valve

- At least one hose bib is not equipped with an anti-siphon device. A possible cross-contamination can occur, which is a potential safety concern. A licensed plumber should install an anti-siphon/vacuum breaker.

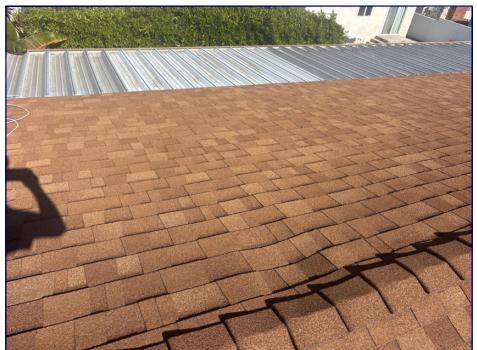
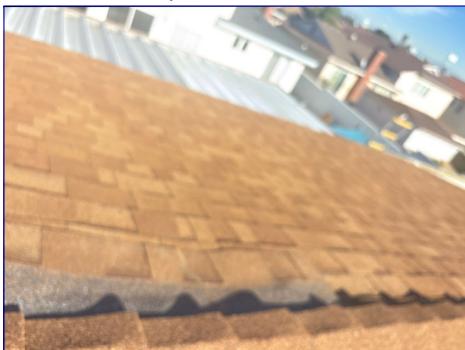
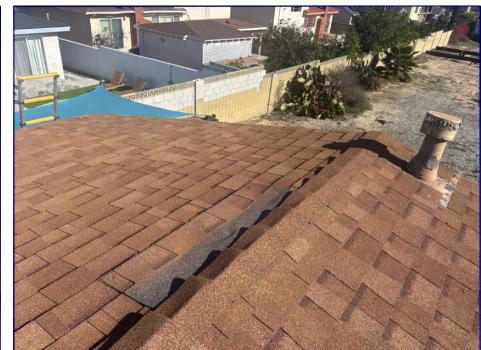
- Sunken area

- There are sunken roof areas. Recommend professional roofers evaluate.

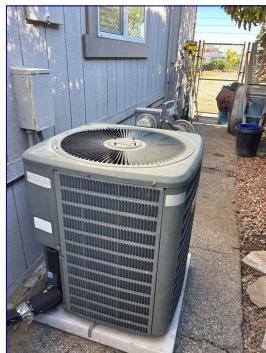
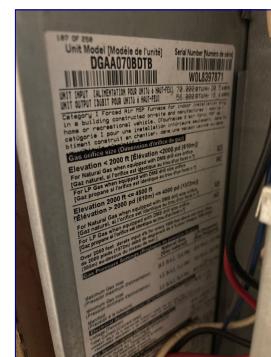
Page 13 Item: 1	Exterior A/C - Heat Pump 1	<ul style="list-style-type: none"><li>The installed breakers for the air conditioning outdoor condensing unit are oversized, according to the manufacturer's data tag, which is a potential safety concern. Recommend a licensed electrician repair.</li></ul>
-----------------	----------------------------	--

- Location: South
- Location: West
- Brand:
- Approximate Age: 20-25+ years
- Energy source: Electric
- Unit Type: Air cooled
- Maximum fuse/breaker installed (amps): 60 amps
- Level: Yes
- Condenser Fins: Need cleaning
- Insulation: Yes
- Improper clearance (air flow): No

- Model # GSC130421AC
- Serial # 0812042101
- The air conditioner is nearing/past its expected life of 8-15 years. Recommend budgeting for replacement.
- Please note; the cooling system contains R-22 refrigerant (Freon). By EPA Standards, this Freon will be phased out starting in 2020. Accordingly, when the air conditioner requires repair to the "closed refrigerant system," the R-22 refrigerant may need to be removed. R-22 may be added to the system if available, or a retrofit option may be available. We recommend saving for repairs and replacement. Consult a licensed HVAC contractor as needed.

- The air conditioner was not operated due to the outside temperature. The unit should not be operated when the outside temperature is less than 60 degrees. Recommend a licensed HVAC contractor clean and check the A/C performance before using.

- The installed breakers for the air conditioning outdoor condensing unit are oversized, according to the manufacturer's data tag, which is a potential safety concern. Recommend a licensed electrician repair.

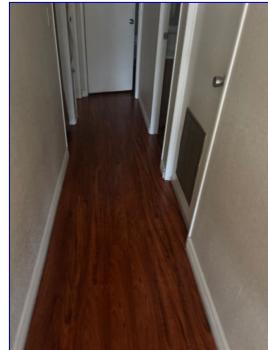
- Squeaks in the hallway near the laundry room

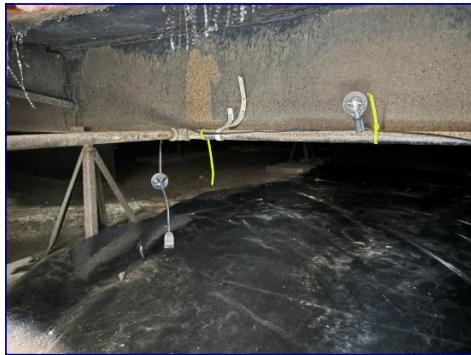
- Vapor barrier present: Only 30 percent of the area

Vapor Barrier:  
• Not visible
