# Property Inspection Report

6115 N. Jensen Place, Placentia, CA 92870

Inspection prepared for: Sam Kim

Date of Inspection: 2/3/2026 Time: 10:00 am

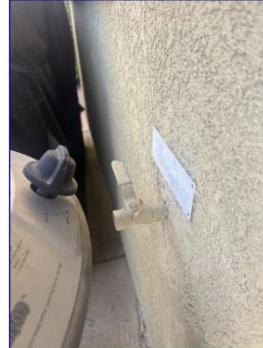
<p>Hose bib operational.</p>
Page 9 Item: 7 Gas System Condition	<ul style="list-style-type: none"> <li>Gas line is not properly capped. Safety hazard</li> </ul>

Unused gas outlet needs to be capped with a real plug on the Westside wall in the back patio

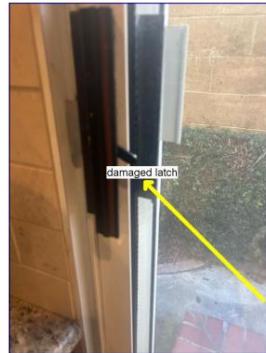
- The Kitchen/Laundry Room sliding door does not open
- The latch is broken

The door latch not working

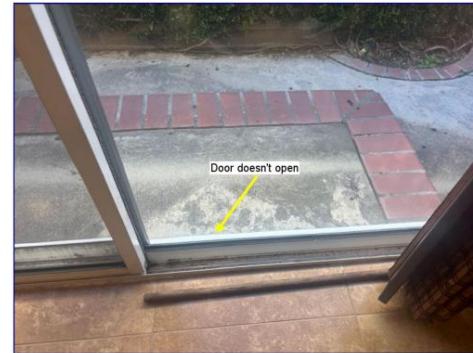
The Kitchen/Laundry Room sliding door does not open

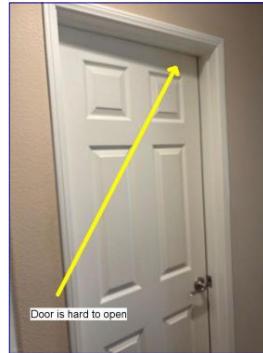
- Door hard to open and close

Door is jammed

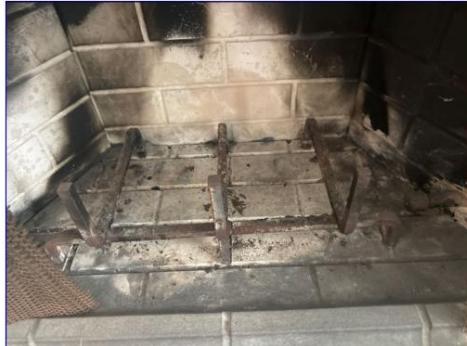
- The Fireplace View: Gas pipe has a plug and the fireplace is unusable

The Fireplace View: Gas pipe has a plug and the fireplace is unusable

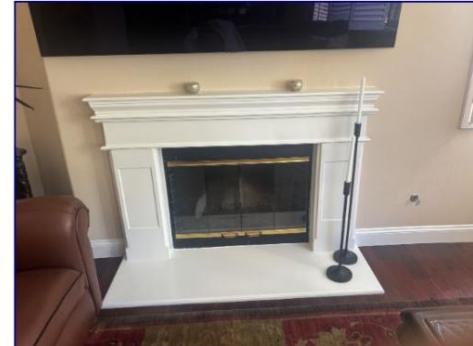
- Fireplace is as line is capped and it is unusable.

Gas line is capped and the fireplace is inoperable

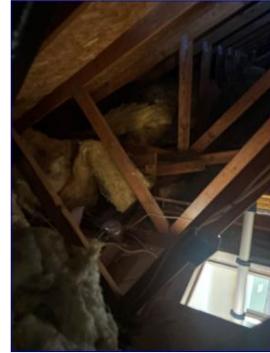
The Attic View	Scuttle Hole not insulated
Page 25 Item: 3 Insulation	<ul style="list-style-type: none"><li>• Insulation is displaced in the attic. Recommend a professional contractor re-distribute the insulation.</li></ul>

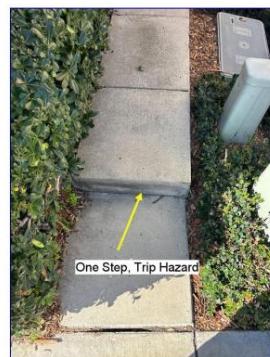
is a trip hazard. Recommend a professional contractor to find the solution • **One step on the walkway is a trip hazard. Recommend a professional contractor to find the solution**

One step on the walkway is a trip hazard. Recommend a professional contractor to fix

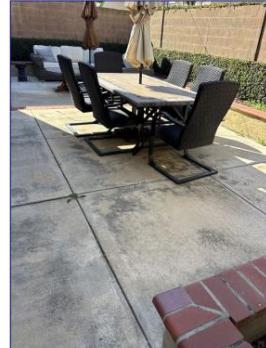
The patio slab has black stains all over. Recommend a through cleaning

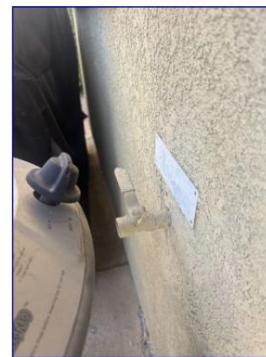
- Gas line is not properly capped. Safety hazard • Gas line is not properly capped. Safety hazard

Unused gas outlet needs to be capped with a real plug on the Westside wall in the back patio

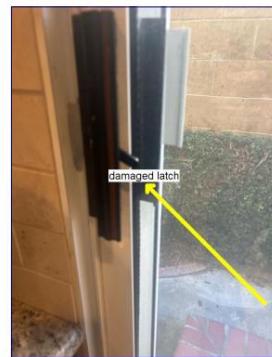
The Kitchen/Laundry Room sliding door does not open • The latch is broken • **The Kitchen/**

The door latch not working

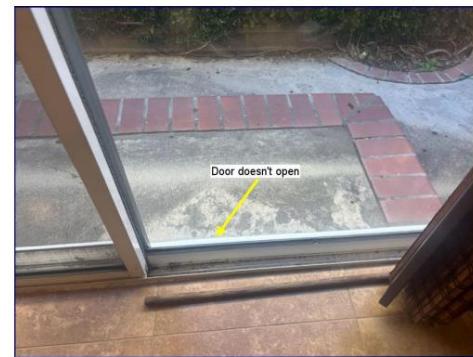
The Kitchen/Laundry Room sliding door does not open

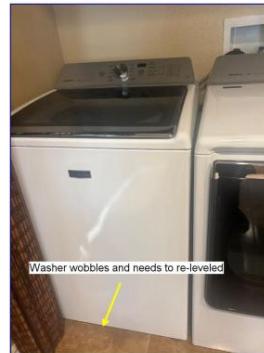
Washing machine legs need to be adjusted not to wobble

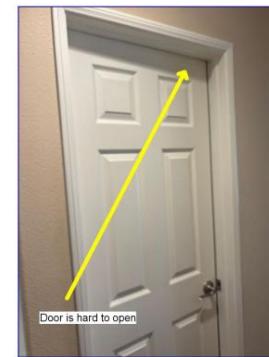
Door hard to open and close • **Door**

Door is jammed

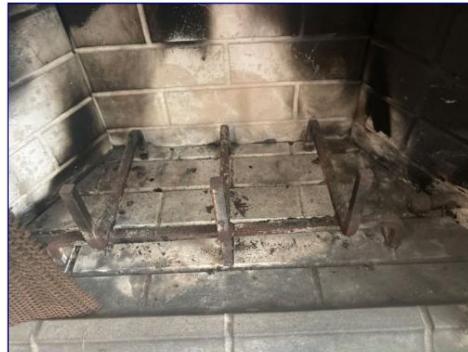
Location: •  
Living room  
Observations: •  
The Fireplace View: Gas pipe has a plug and the fireplace is unusable • [The Fireplace View: Gas pipe has a plug and the fireplace is unusable](#)

The Fireplace View: Gas pipe has a plug and the fireplace is unusable

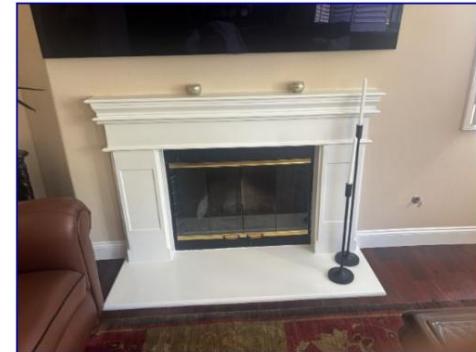
Fireplace is as line is capped and it is unusable. • Fireplace is as line is capped and it is unusable.

Gas line is capped and the fireplace is inoperable

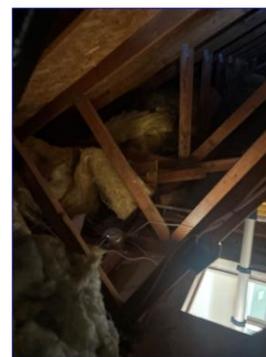
Scuttle Hole not insulated

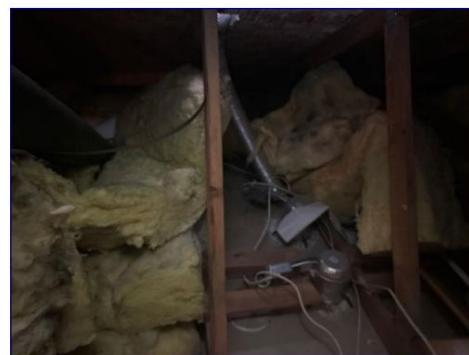
displaced in the attic. Recommend a professional contractor re-distribute the insulation. • Insulation is displaced in the attic.

Insulation is displaced in the attic. Recommend a professional contractor re-distribute the insulation.
