# Property Inspection Report

6115 N. Jensen Place, Placentia, CA 92870

Inspection prepared for: Sam Kim

Date of Inspection: 2/3/2026 Time: 10:00 am

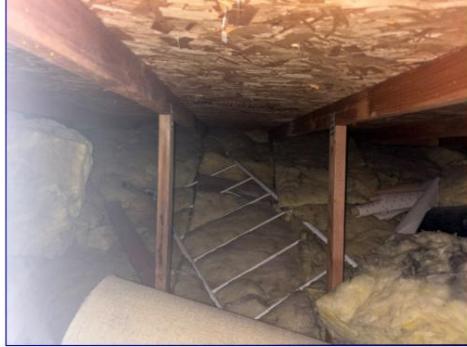
Page 25 Item: 1 Access to Attic/Inspected From/Location	<ul style="list-style-type: none"><li>• Attic Insulation is displaced • There are personal items in the attic. Recommend to remove them.</li></ul>

The Attic View	Scuttle Hole not insulated
Page 25 Item: 3 Insulation	<ul style="list-style-type: none"><li>• Insulation is displaced in the attic. Recommend a professional contractor re-distribute the insulation.</li></ul>

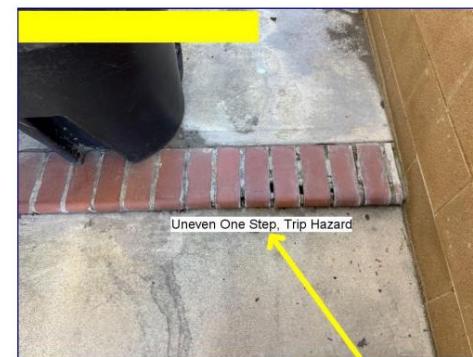
The step risers are uneven on the exterior steps, which may present a trip hazard. Recommend a licensed general contractor repair or replace as needed. • The Steps/Stoop View

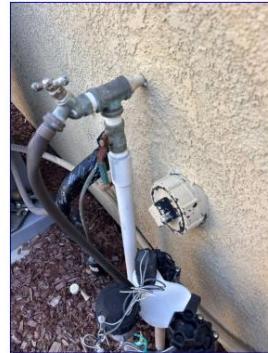
Hose bib operational.

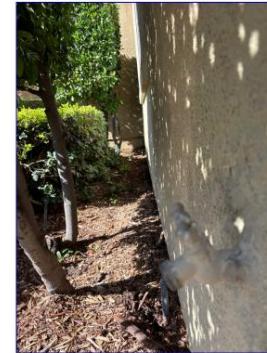
Hose bib operational.

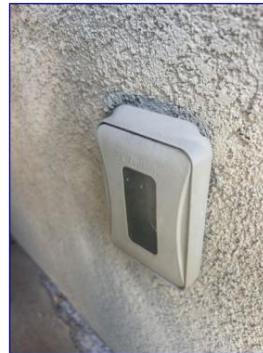
Located in the Westside wall in the back

Receptacles/Condition: •  
Exterior receptacles: Yes •  
GFCI present: Yes •  
GFCI, operable: Yes

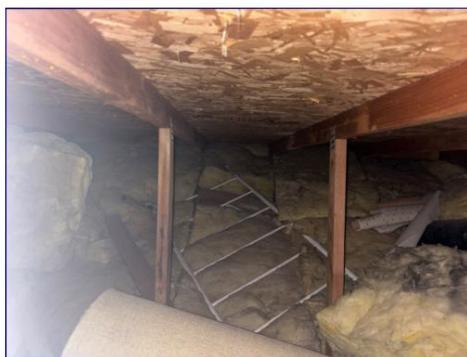
The Attic View

are personal items in the attic. Recommend to remove them. • Attic Insulation is

displaced • There are personal items

in the attic. Recommend to remove them.

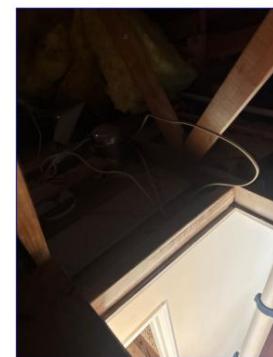
Scuttle Hole View

Scuttle Hole not insulated

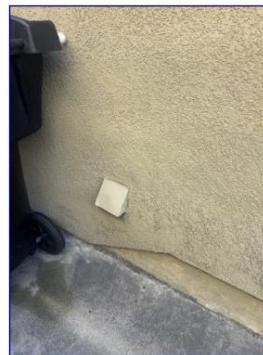
Dryer vent present
